# Flicka Friends

Spring 2006

Vol. 11, No. 1

Restoring A Rare Original  
Gaff Rigged Flicka  
s/y HARMONY ..... 6  
Steve Grisanti

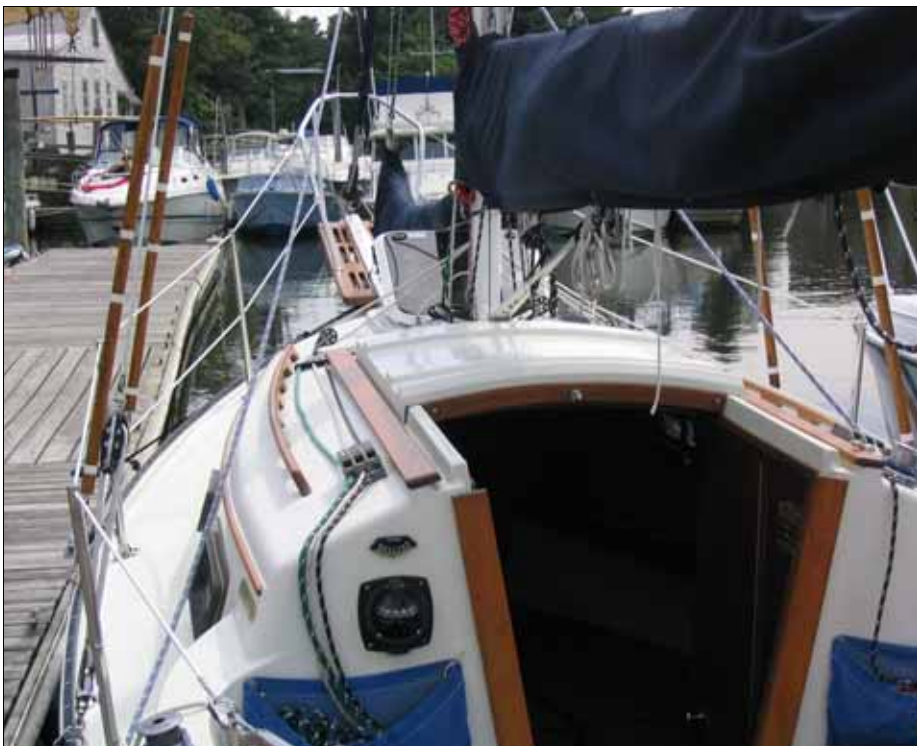
All of the lines are led aft to the cockpit.

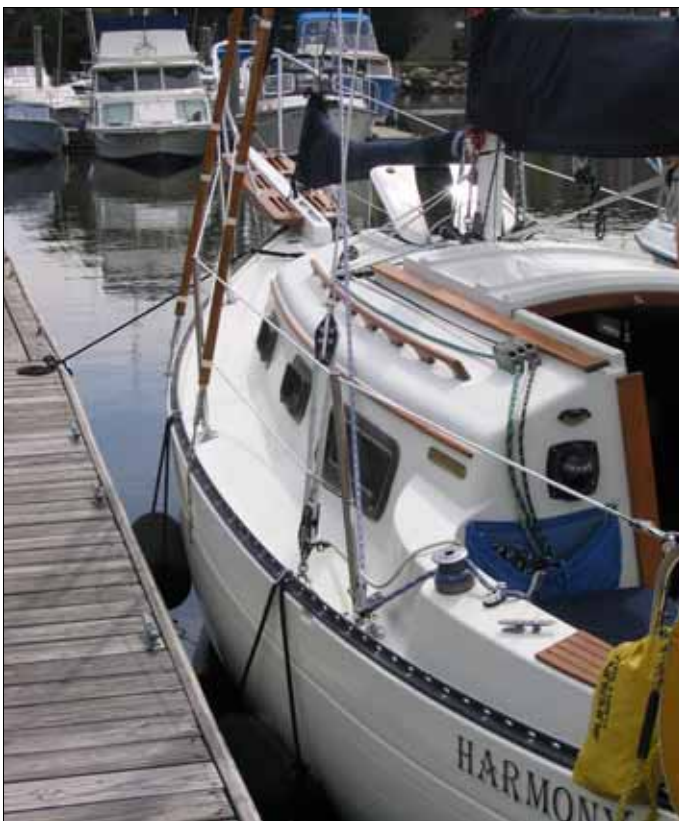
The slotted rail is powder coated.

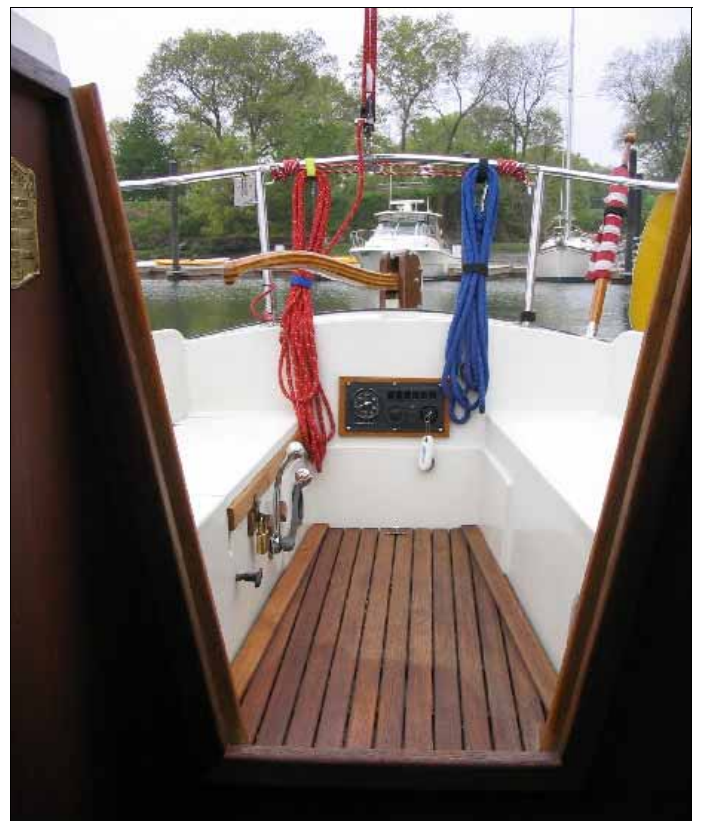
Companionway and teak cockpit gate.

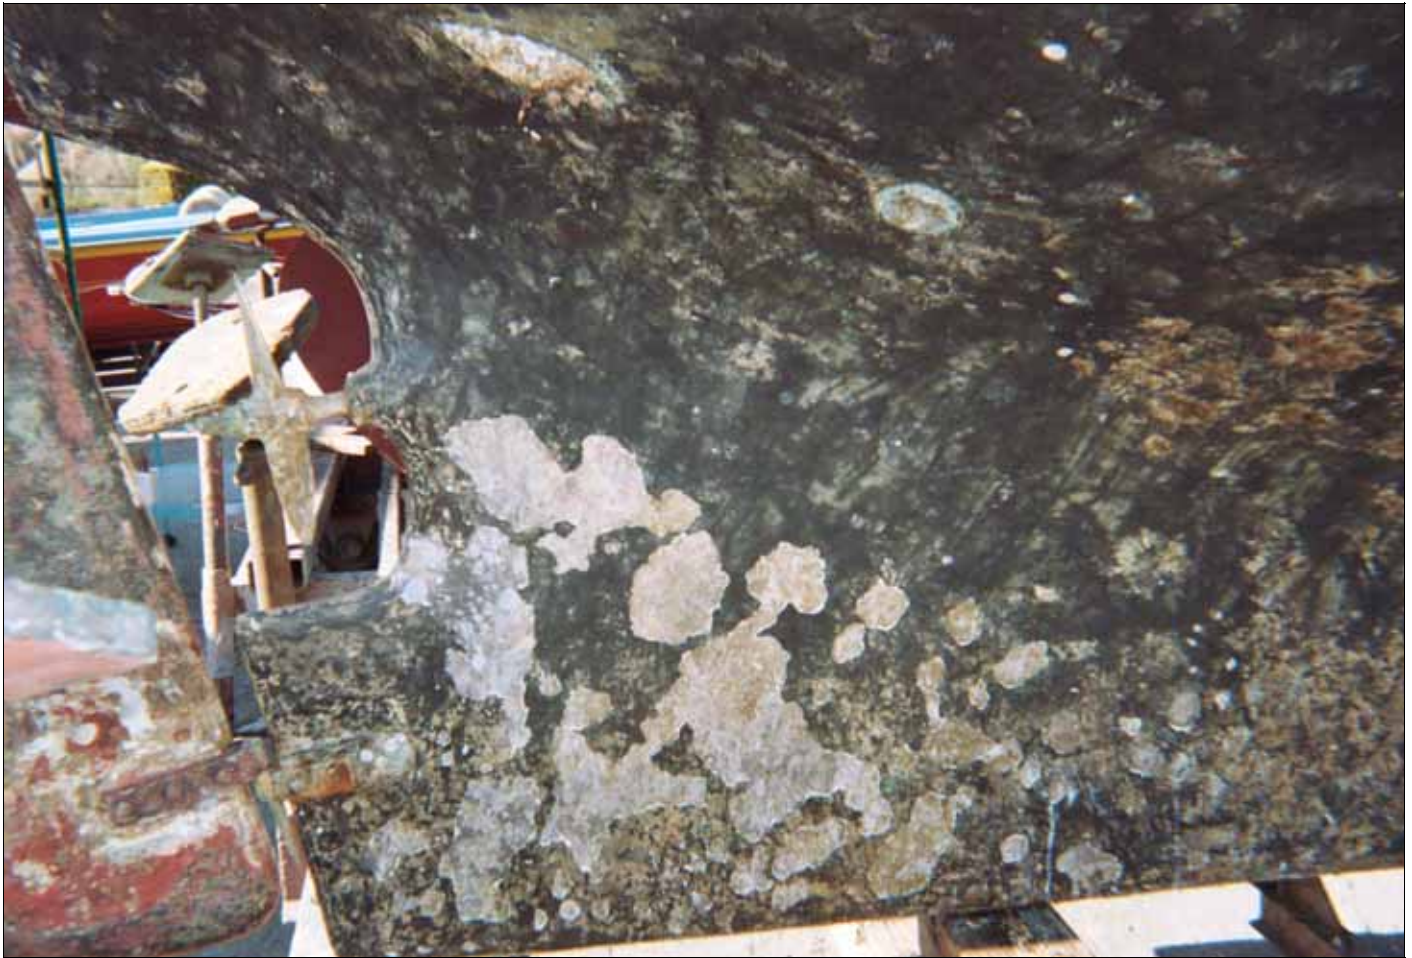
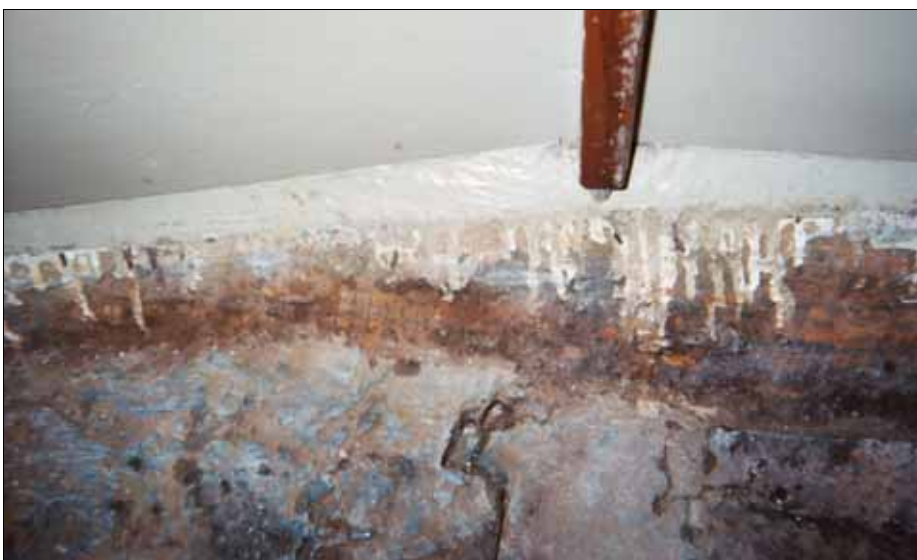
With JUNO on dry land, the inspection process began.  
*Photo: Christopher Toomey © 2006*

Over a period of two days, starting with a paint scraper and a thin bladed putty knife I opened blister after blister, finding often, that with the putty knife I could easily lift off small sheets of thickly applied resin that had separated from the hull. This went on until, as can be seen in the pictures of the painted areas, just about the entire lower aft end of the keel mass was cleared of loose material. I figure that most of the blistering was concentrated there because of the density of the concrete in that area. I was concerned to find that on the port side the blistering was occurring up higher along the hull but this turned out to be one isolated spot.

There were two small, more serious issues below the waterline. One of them was an area near the shaft log where the mortar had become loose and powdered beneath a softball sized blister. Fortunately, somehow the area had stayed dry and there was no rust on the exposed mesh.

In another spot beneath a blister forward along the leading edge of the keel mass, I found a dollar-sized area of wet concrete with exposed, rusted mesh. Both of these areas were cleaned and covered with Marine-Tex.

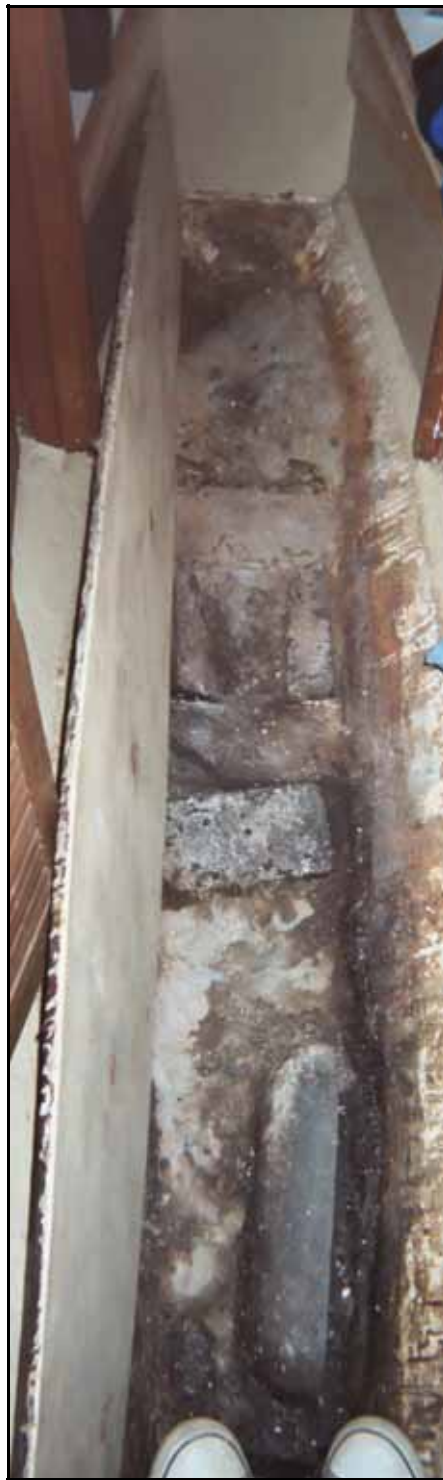
**Lifting the floorboard showed some of the ballast.**

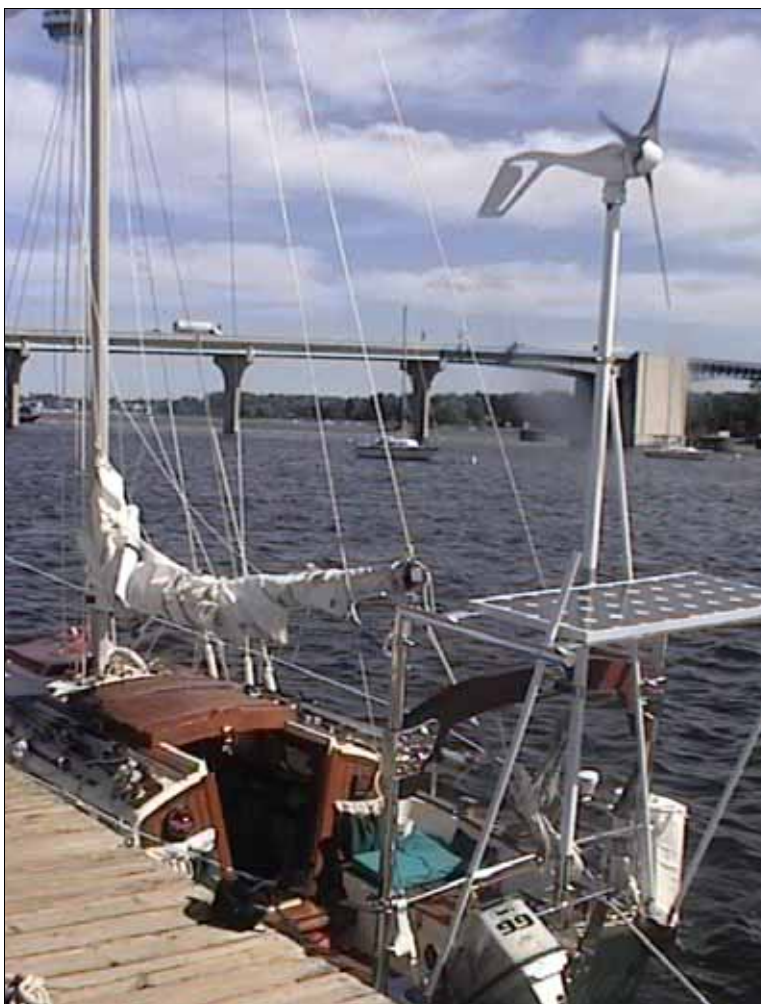
**The gallows supports a wind generator and solar panel.**

inside of the stern cockpit. Each is one sturdy piece and a solid part of the boat. The boom gallows can also be disassembled by simply unbolting the lower poles from the inserts and taken off. Except for the mounting brackets, I am then down to the basic Flicka look.

The clearance on all the pole inserts is less than 1/64," so when double-bolted from 180-degree directions with 3/4" SS bolts, there is zero movement or rattle of any of it.

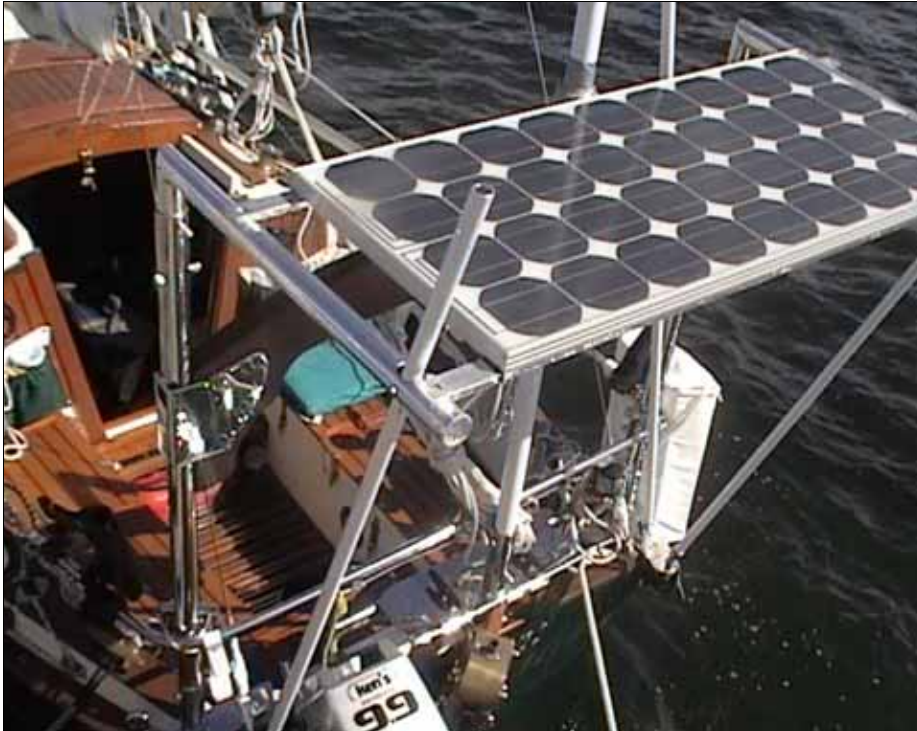
**A single solar panel produced power even if the wind cannot.**

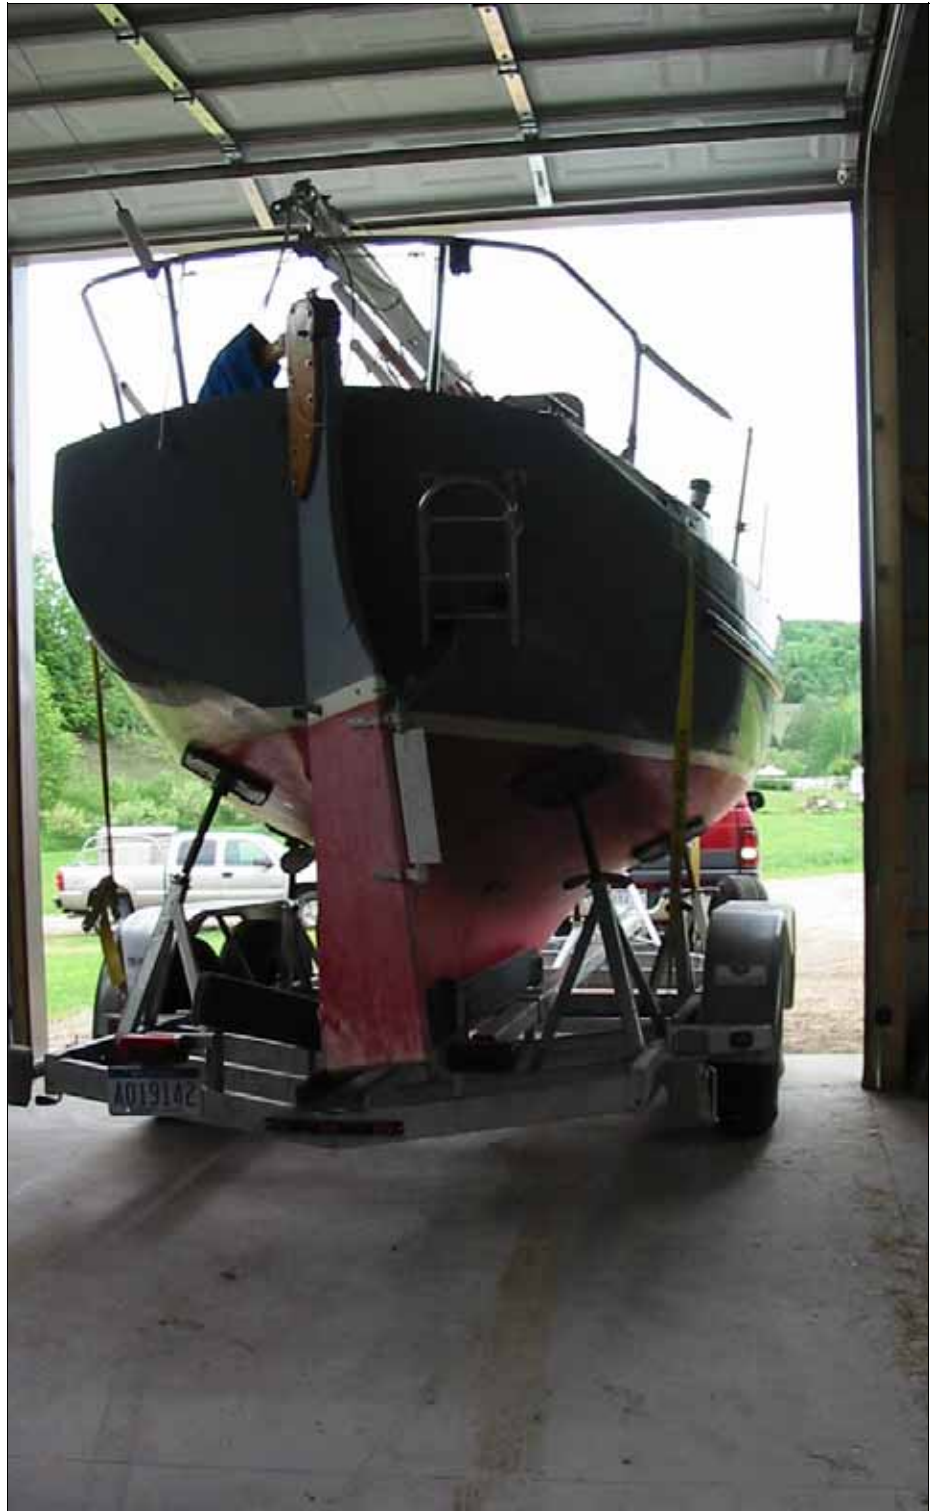
**The twelve foot wide and twelve foot high door makes backing a Flicka into the barn very easy.**

Tom Grimes decided to build a boat storage building over the winter. The first step was deciding on how big to build the structure. When you put a Flicka on a trailer, the rough dimensions are eight and one-half feet wide, twenty six feet long and eleven feet tall. The height is measured from the bow pulpit to the ground. The length includes the rudder and the trailer tongue. The width includes the trailer fenders which are the widest point.

The decision was made to build the boat barn forty feet long and thirty-two feet wide. This would provide roughly six feet in front of and behind the Flicka and trailer. The trailer would be three feet from the back wall. The width will allow plenty of room for parking the trailer and enough space for a small office and work room. This office would take up twelve feet, leaving

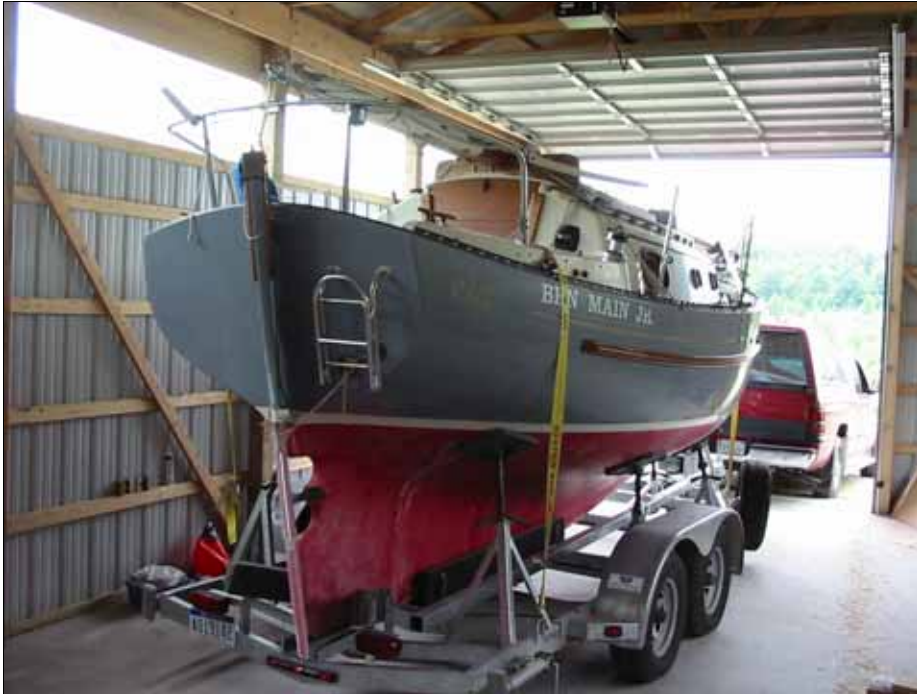
The barn is forty feet long, plenty of room for the Flicka and the Triad trailer. Clear panels provide plenty of light inside.

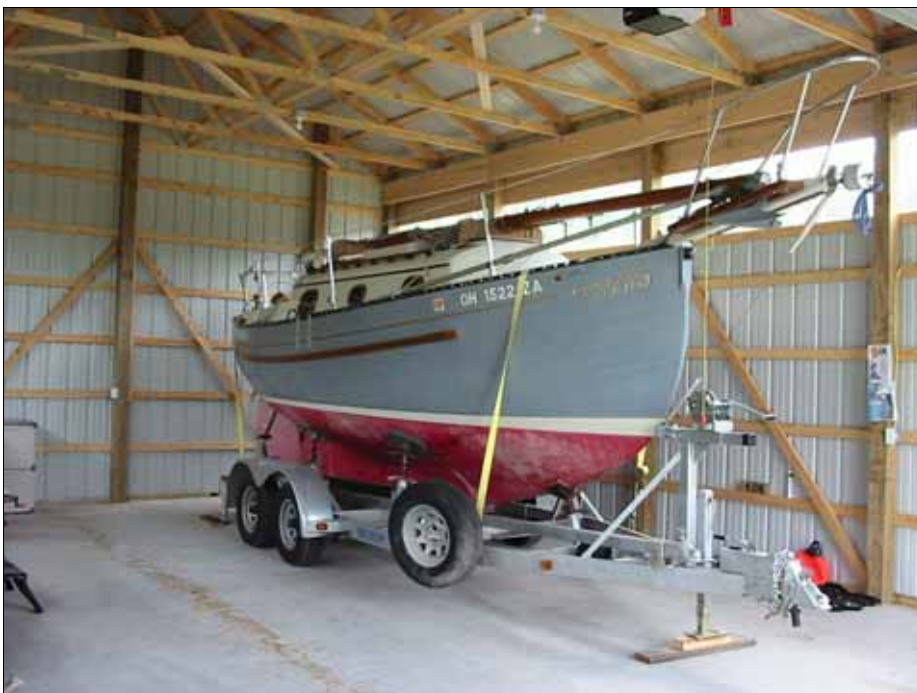
The floor is rated for 10,000 pounds per square foot, more than enough for the Flicka and trailer.
